THE FAILURE OF A NATURAL GAS TRANSMISSION PIPELINE CAUSED BY A THIRD-PARTY DAMAGE

Abstract: In this paper there are outlined the investigation results of a technical accident that took place recently on a natural gas transmission pipeline, due to the damage of one of the pipes, caused by a third party interference. In order to determine the failure conditions of the pipeline that experienced this technical accident, the authors used more assessment procedures for defects like dent – gouge combinations, generated by third party damages upon this pipeline. The results of the research performed led to the selection and assigning of the measures that have to be taken in order to keep at an allowable level the risk for such events to occur on natural gas transmission pipelines.

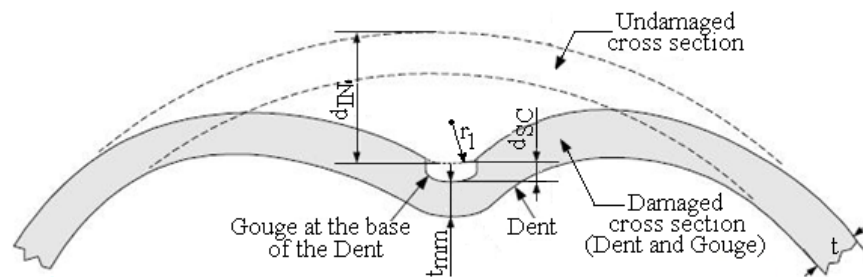
Fig. 1. Modification of the cross section configuration of pipelines in the areas with anomalies like dents with gouges – IS.

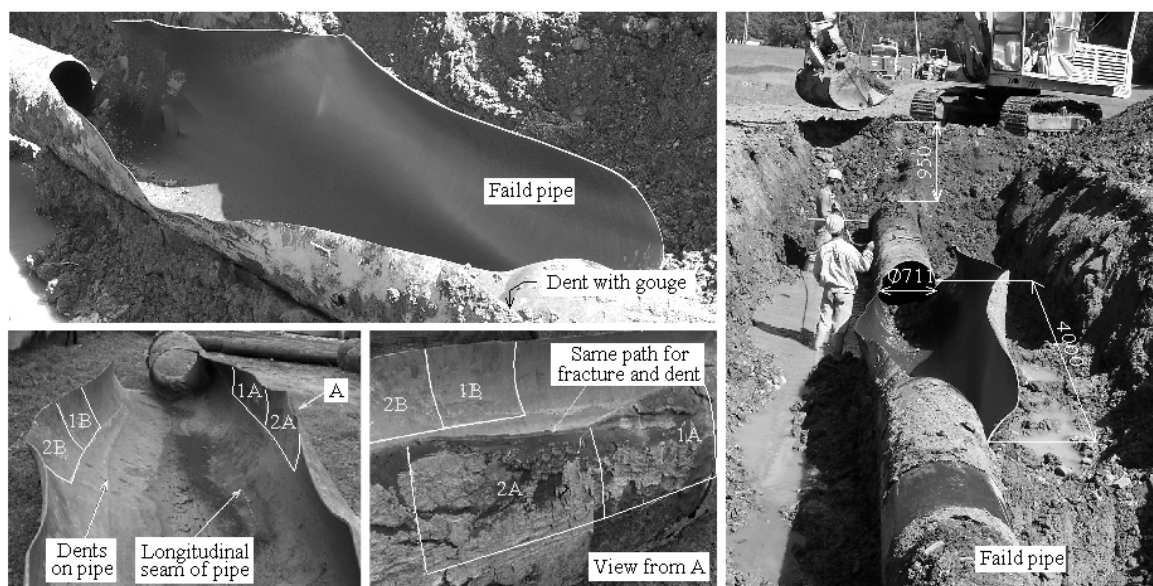
The images shown in Figure 2, which reproduce the aspect of the damaged pipeline, highlight the amplitude of the accident. The examination performed at the place of the accident led to the following preliminary hypotheses regarding the way it occurred [3]: a) the failure had an explosive character, the fracture having the characteristics of a ductile fracture, with no fragment displacement from the pipe that failed; b) the failure initiated on a longitudinally welded pipe revealing marks of a third party damage, one could notice many dent – gouge combinations, probably produced by the action of the active elements of a working equipment (excavator, scraper, launcher etc.) upon this pipe; c) anomalies like dents with gouge constituted mechanical stress concentrators, in the area where the initiation and the propagation of cracks under the circumstances of some fluctuations or accidental peaks of mechanical stresses of the conveyed gas was favored.

Fig. 2. The area where the explosion of the pipeline occurred and the pipe that failed in service.

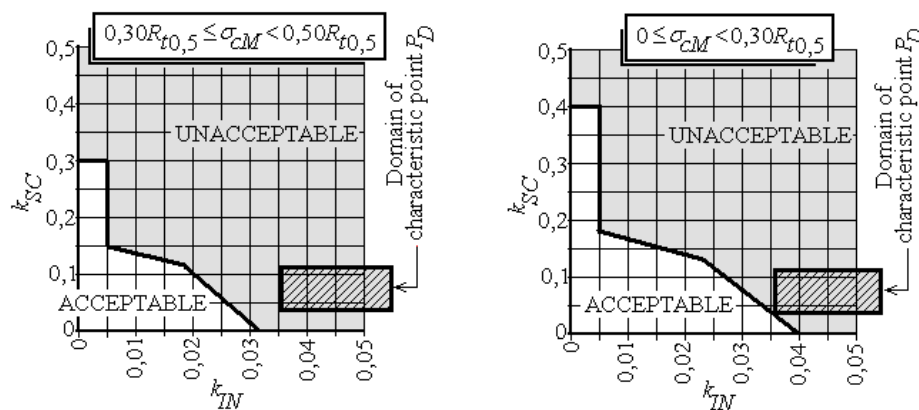
Fig. 3. DAA charts for the level 1 assessment of the IS anomalies of the pipe that failed in service.
