## EMPHASISE OF SOME PECULIAR ASPECTS OF A PIPELINE CORROSION DAMAGE DUE TO CITADINES WORK CONDITIONS¶

**Abstract:** The paper presents the results of a case study of a failure analysis on a pipeline component serviced about 20 years in an underground structure for oil transportation, between a railway station and a thermal power plant, as result of interaction with urban environmental attack.

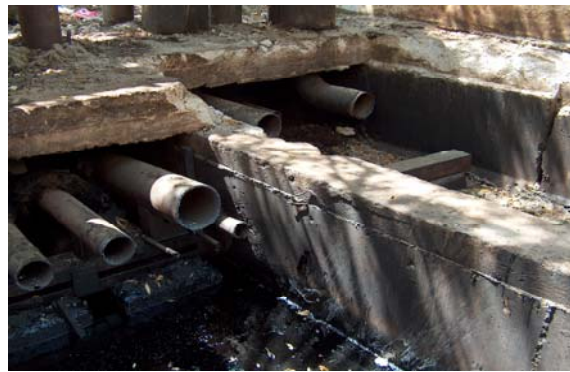
Fig. 1 – Generals aspect of the location – access to the failure zone

- f) no general corrosion, even internal (figure 2), or external (figure 1) was present;
- g) due to the steam circulation, some interesting indents aspects were registered even far from the damaged area (figure 4); such internal aspects were also present in the area of failure, but here the indents disposition has followed the stem un regular circulation (figure 5);

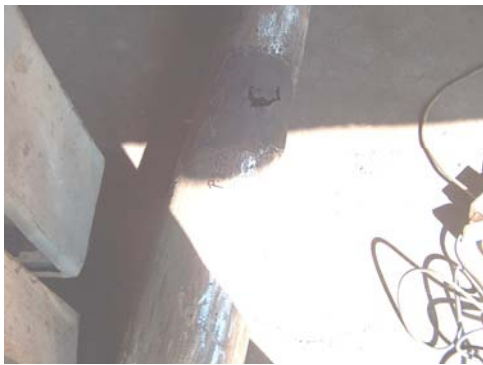
Fig. 2 – The failure zone – external detail

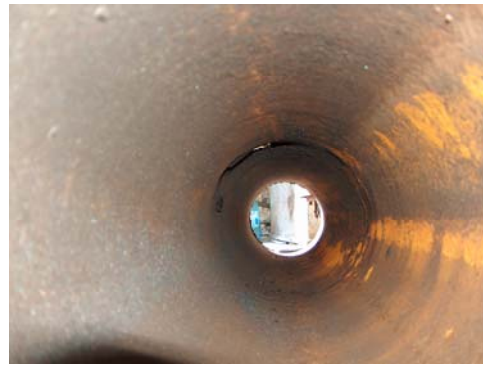
Fig. 3 - The failure zone – internal detail

- e) the two oil pipelines, branches of the same system, were nor perfect symmetrical, the branch quoted P1 being deeper, since P2 (with the final failure – figure 3), being 2 m upper to the road level; the level difference between the two branches was solved by elbows, but no corrosion or mechanical damages were identified for these elbows;

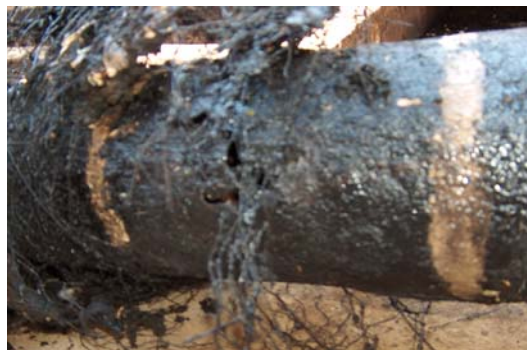
- a) the transportation pipeline was commissioned in 1988;
- b) the permanent corrosion protection was an bituminous coating supplementary reinforced by wire nets and mineral/glass fibber; the effectiveness of this protective system is high to be discussed, since only few small traces were still present at the time of the assessment ( as shown in figure 4).

Fig. 4 – The failure zone – external detail, traces of protective system

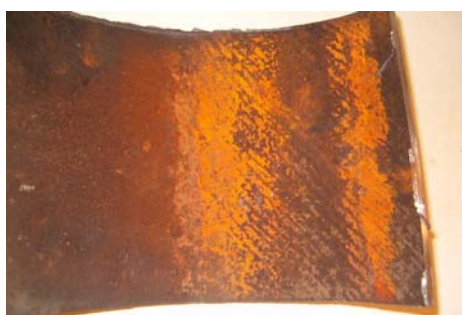
Fig. 5 – The external detail, steam indents

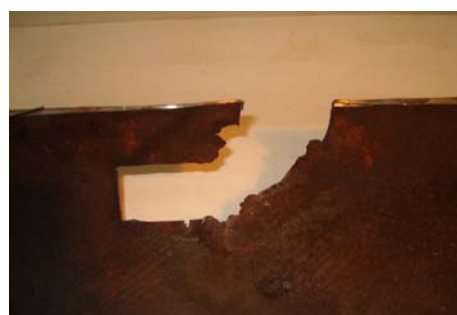
Fig. 6 – The external detail, steam indents, irregular

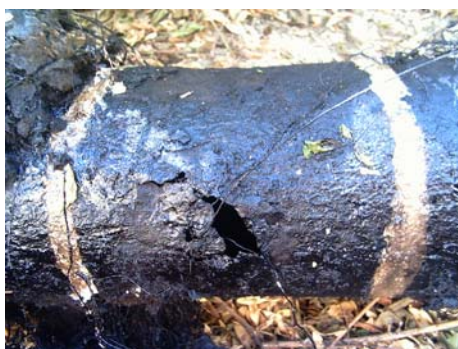
- h) the failure place was at about 2 m from the nearest tram line in a region at 13 – 14 hour, where the wall thickness was about 1 mm as results of external consumption; some corrosion products were present; the main corrosion mechanism was of an anodic consumption due to the interference between the pipeline and the high voltage supplying system;
- i) the failure was an time dependent process, since the rupture scenario have followed at least few stages, like figure 7 allow to interpretation:
- wall thickness consumption from the external side, till a critical thickness in respect to the actual rezistance properties;
  - explosive failure, by overloading, with important deflection;
  - continual wall degradation during operating in such condition till a total damaged surface of about 100 mm<sup>2</sup>, when the fluid lost was significant and environment was affected;

Fig. 7 – The external detail, failure

The steel pipe failure is due to external corrosion, and the mechanism of interference with high voltage systems is evident.

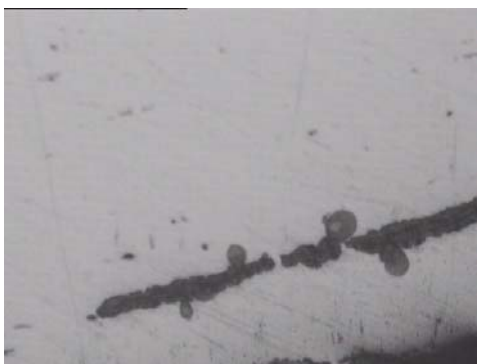
Fig. 8 – Steel impurities, unetched x 100

Such behaviour was considered in relationship with microstructure aspects, where sulfide plastic impurities were spectacular growth, and it could be explained only by hydrogen atoms trapped at these impurities, release due to testing conditions (250 °C and 45 minutes heating duration).

The future maintenance have to consider a active process of hydrogen arrest into sulfide plastic impurities that are now at an important size even in longitudinal and transverse directions.
