GALVANIC CORROSION IN COOLING WATER ENVIRONMENTS

ABSTRACT: Severe galvanic corrosion problems have been identified mainly in heat exchangers used in several industrial cooling systems from chemical plants, refineries, power plants. The causes of heat exchangers failure and the modalities to avoid it in the future are discussed, emphasizing mainly the role of design, operation, maintenance and reparation of this type of equipment.

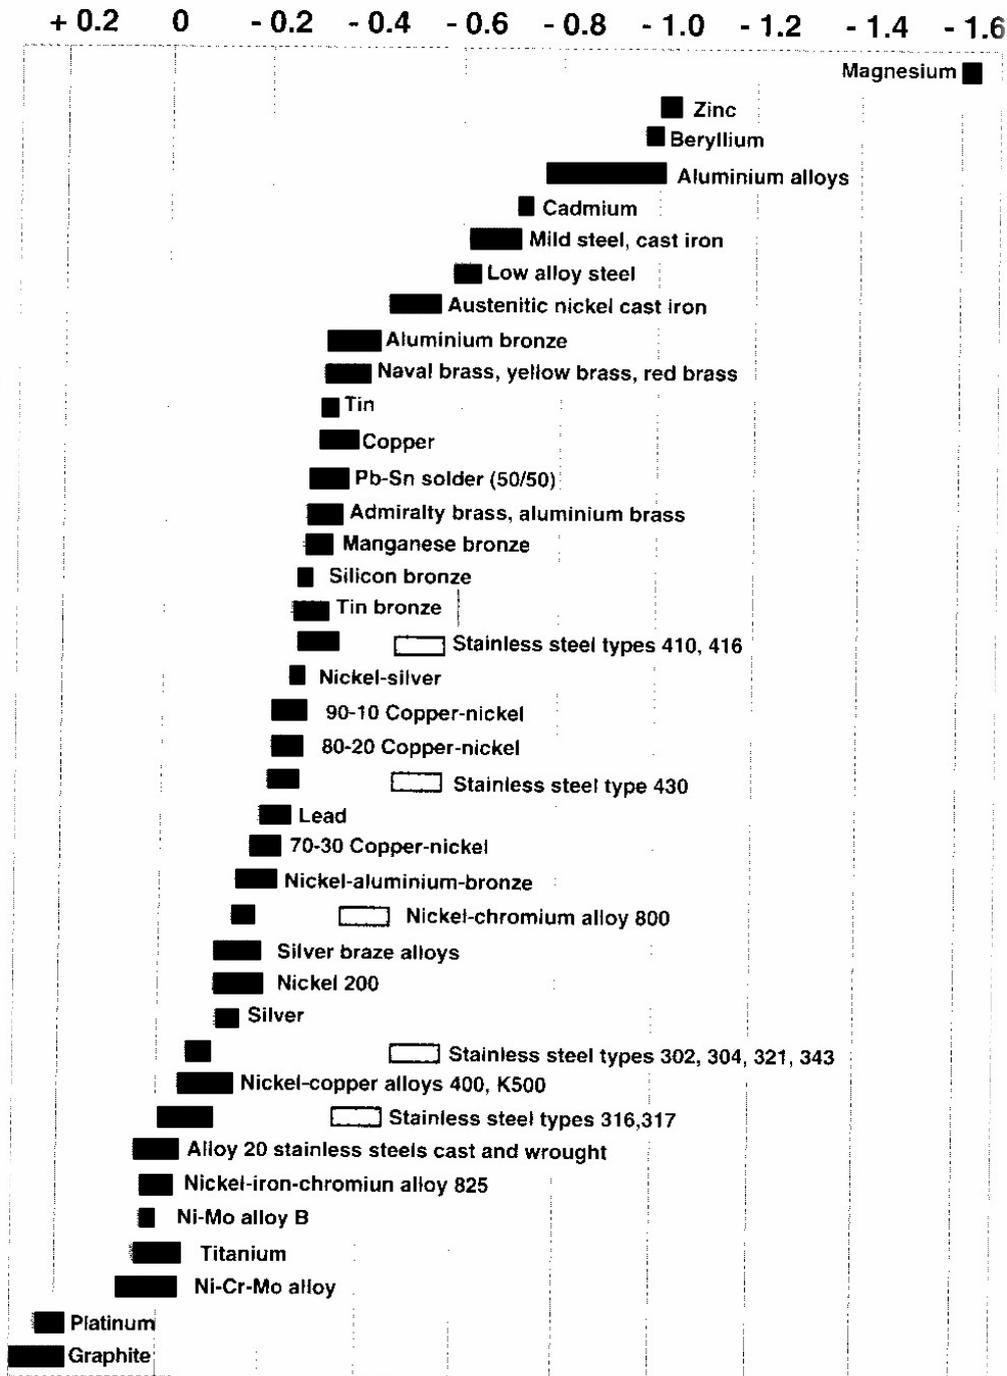
Fig. 1. Galvanic series in seawater [5]

Alloys are listed in the order of the corrosion potential they exhibit in flowing sea water (2.5-4m/sec, 10-27°C)

Alloys indicated by in the chart may become active and exhibit a potential near -0.5volts in low-velocity or poorly aerated water, and in shielded areas

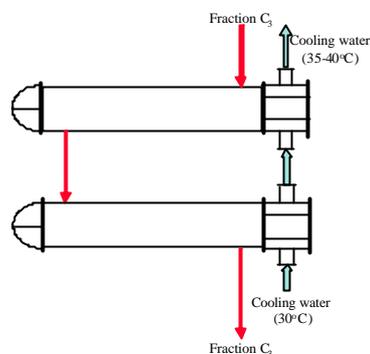
Fig. 2. Fraction C₃ cooler from a gas plant associated with a FCC unit

In an oil refinery, the mild steel fraction C₃ cooler of the gas plant (Fig. 2) was retubed with AISI 304 SS (EN 1.4301) tubes to avoid the frequent shutdowns caused by the tubes' failure. The SS tubes were more resistant, but at the next annual shutdown severe galvanic attack was reported on the tube sheet, the separating walls from the inlet water boxes, and the reinforcing bars between the walls (Fig. 3). Due to the advanced corrosion, most of the separating walls have to be replaced.

For remediation, zinc sacrificial anodes were mounted on the separating walls of the inlet water boxes.

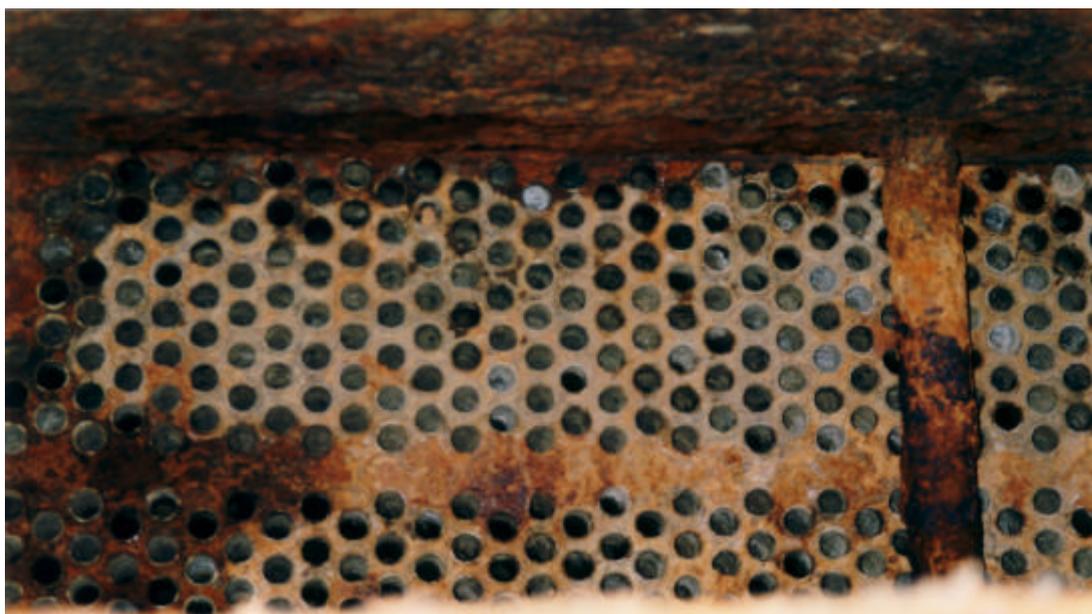
Fig. 3. Galvanic attack at the inlet water box of the fraction C₃ cooler

- a high level of dissolved salts in the recirculated cooling water, which exhibited an average TDS content of 1,600 mg/L and a conductivity in the range of 1,000 - 4,000 $\mu\text{S}/\text{cm}$;
- a reduced flowing rate of the cooling water (specially during cold seasons, when operating personnel strangles the cooling water exit from the heat exchanger, in order to maintain the prescribed temperature of the cooled gases).

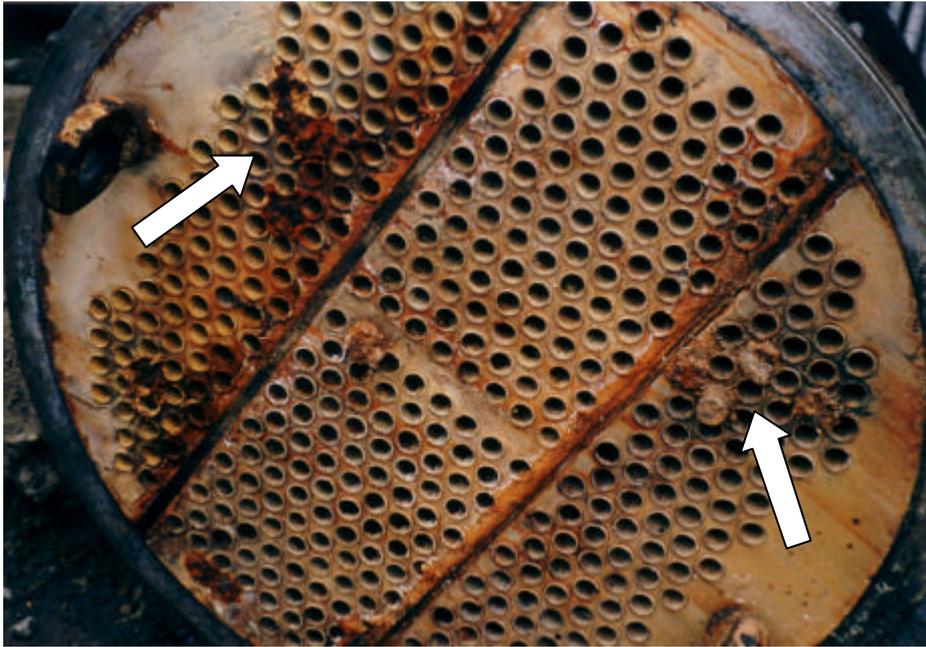
Fig. 4. Water inlet tube sheet of the amine stripper condenser

In a sulphur unit recovery plant from an oil refinery, as an amine stripper condenser a four way, water-in-tubes, horizontal shell-and-tubes heat exchanger was used. Due to the aggressiveness of the process fluid, tube bundle and tube sheets were made in AISI 321 SS (EN 1.4505). After six months of operation, a leakage was detected; at the hydraulic test 12 tubes were found damaged and the decision to plug them was taken. At each end of the leaking tubes carbon steel plugs were beaten, and the exchanger was reintroduced in circuit. Within a couple of months, at a scheduled inspection, an advanced corrosion of the plugs has been reported (Figures 4 and 5).

A galvanic cell with chemically treated cooling water as electrolyte, carbon steel plugs as cathodes, and SS tube sheet as anode was formed. The high area ratio between the noble anode (SS tubes and tube sheets) and the active cathode (mild steel plugs) favoured and accelerated the process.

For remediation, carbon steel plugs have been removed and replaced with AISI 321 SS plugs welded on the tube sheets. There were no more corrosion problems on the cooling water side.

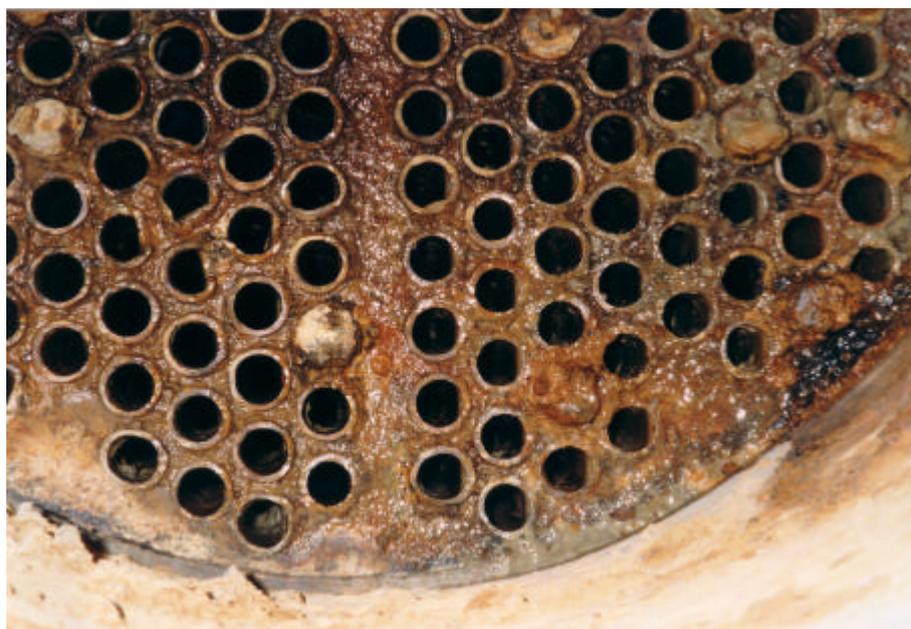
Fig. 6. Water inlet tube sheet of the C₄ fraction cooler

Similar situations have been reported in the same refinery, at the C₄ fraction cooler and at the C₃-C₄ fraction cooler located in the gas plant of the FCC unit (Figures 6 and 7). Both heat exchangers were equipped with AISI 304 SS (EN 1.4301) tubes, but due to the fact that tube sheets were made in mild steel, galvanic corrosion of carbon steel plugs developed slower, a smaller anode - cathode area ratio being achieved.

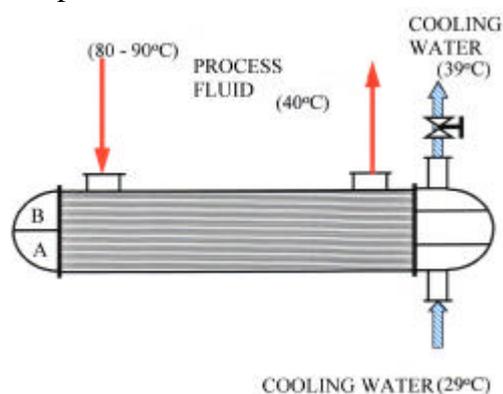
Fig. 8. Ammonia carbamate solution cooler

A cooler for diluted ammonia carbamate solutions from a urea plant (Figure 8) has the features presented in Table 2.

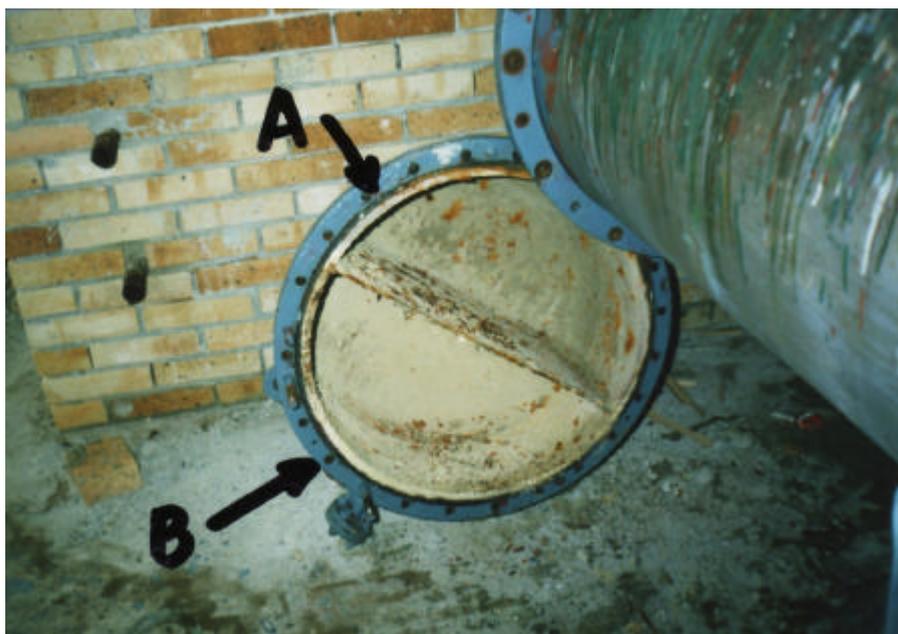
Fig. 9. Ammonia carbamate solution cooler - water turning end

At a yearly shutdown, large amounts of tubercles (main component iron oxide) and mud have been found in the “A” area of the water turning end of the exchanger. The separating wall from that end being in contact with the tube sheet (also made in AISI 304L SS = EN 1.4306) has been severely corroded, its thickness being reduced from 5 to only 2 mm (Figure 9).

No repair was made to the wall, but an insulating asbestos gasket was fitted between the water turning and the tube sheet. After another year of operating in inhibited cooling water (128 mg/L chlorides, 228 mg/L sulfates, 1,500 μ S/cm conductivity, pH = 7.0 - 7.9), the corrosion of the separation wall has been accentuated. Low flow rates (process fluid temperature control was done by closing the cooling water outlet valve) allowed the suspended solids accumulation in the lid (Figure 10). The galvanic cell formed by the noble tube sheet and the reactive wall was active, leading to the final damage of the wall (Figure 11), that was replaced with a new one, made in mild steel also.

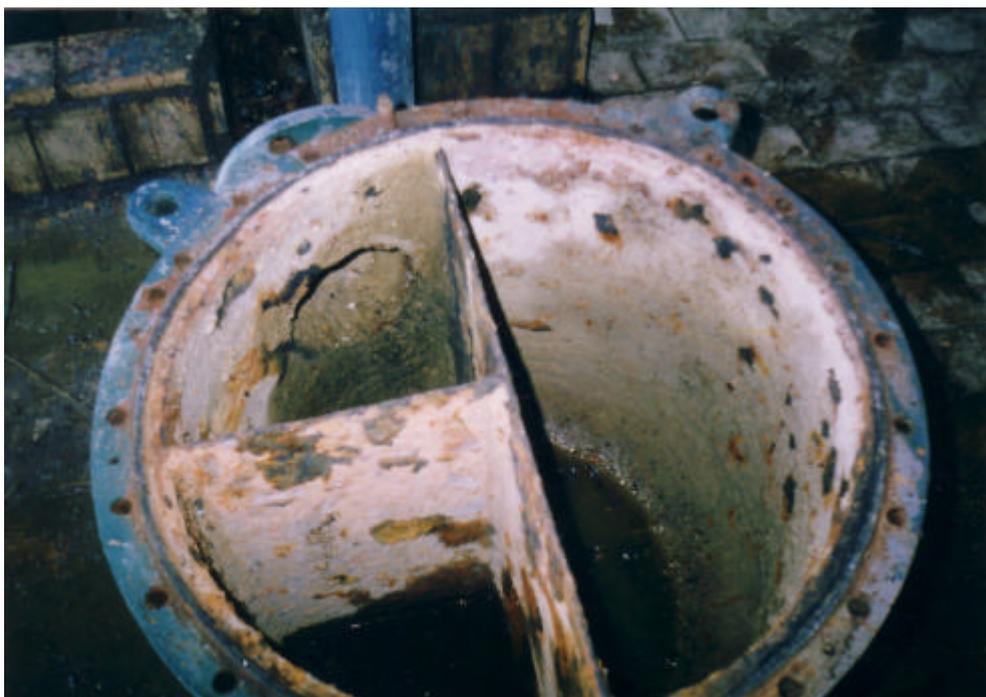
Fig. 12. Ammonia carbamate solution cooler: water inlet head box after washing

The same phenomenon was encountered to the inlet water box too (Figure 12).

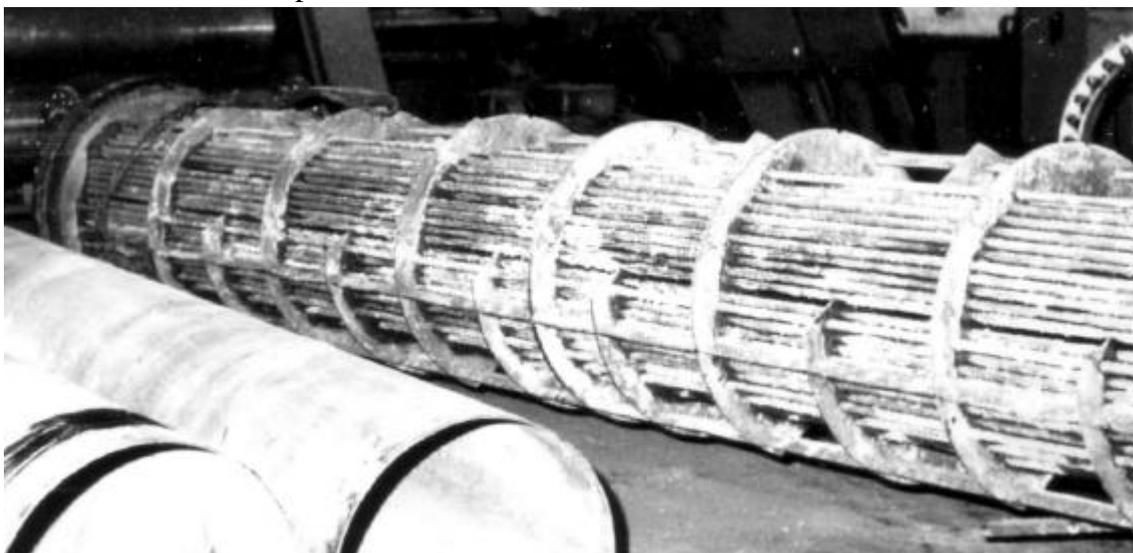
Fig. 13. Mild steel tube bundle of the Carsol[®] cooler after 3 years of operation in untreated cooling water

After only three years of normal operation, with untreated cooling water, the spent Carsol® cooler, exhibited advanced corrosion (mainly tuberculation) outside the tubes (Figure 13). Also, due to the aggressiveness of wet CO₂ frequent tubes damage were

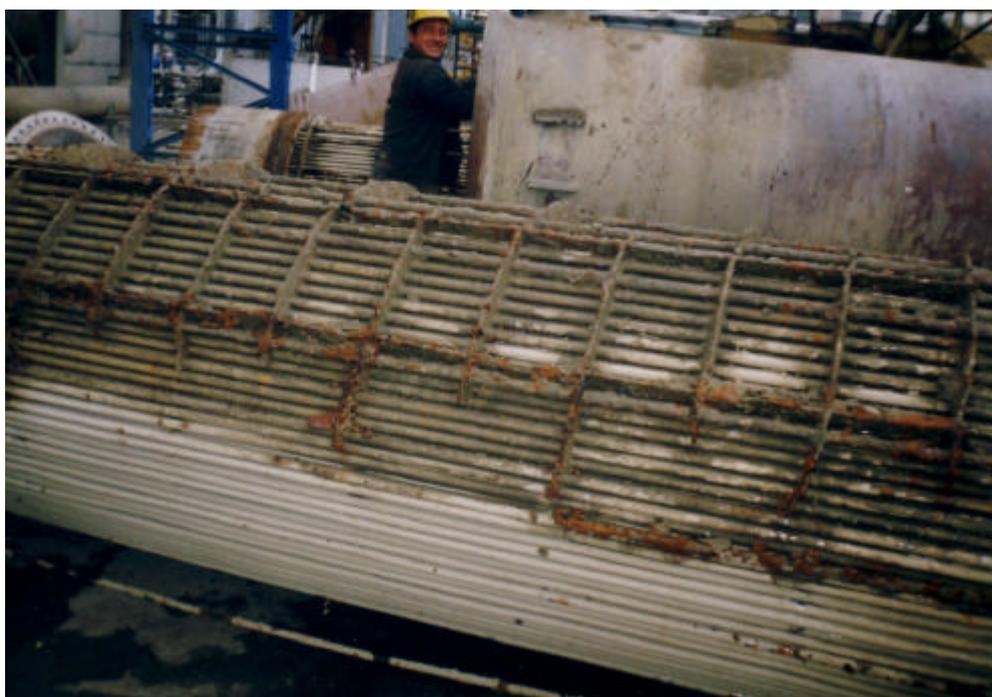
Fig. 14. Tube bundle of a wet CO₂ cooler right after dismantling

The replacement of tubes, without taking in consideration of what will happen when noble SS tubes will be in contact with mild steel baffles and rods, in a conductive environment (150 mg/L chlorides, 150 mg/L sulfates, 1,000 mg/L TDS, 1,250 $\mu\text{S}/\text{cm}$ conductivity) was unhappy. Due to the large anode (SS tube bundle) / cathode (MS baffles and rods) area ratio, the baffles and rods were severe corroded within months (Figures 14 and 15). There were no more leaks from the process side, but the cooling process worsened due to the water hydrodynamics unfavorable changes.

To avoid baffles destruction, these should be made in the same 316 SS or, at least, in 304 SS. In this case, as it was seen at several CO₂ coolers from a urea plant using very similar cooling water, there will be no more damage to the flow profile of the cooling water on the shell side. Nevertheless, the mild steel heat exchanger shell will be attacked in the contact area with the SS baffles. The galvanic attack will be however reduced, the anode / cathode area ratio being less favorable to the corrosive attack (Figure 16).

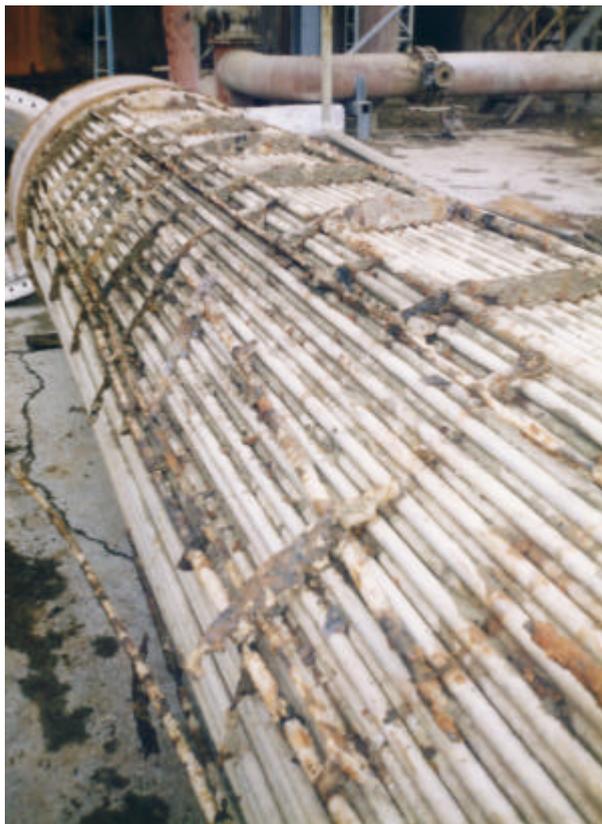
Fig. 15. Severe galvanic attack of mild steel baffles and rods in contact with the 316 SS tube bundle

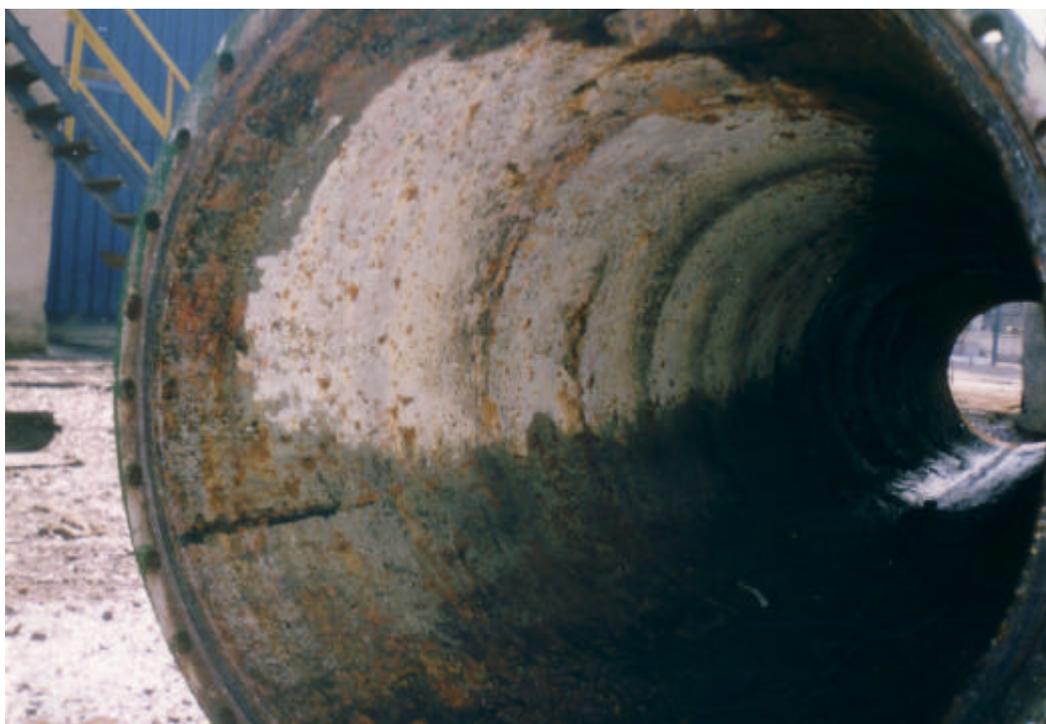
Fig. 16. Mild galvanic attack of the carbon steel shell of a CO₂ cooler (urea plant), due to the contact with 304 SS baffles

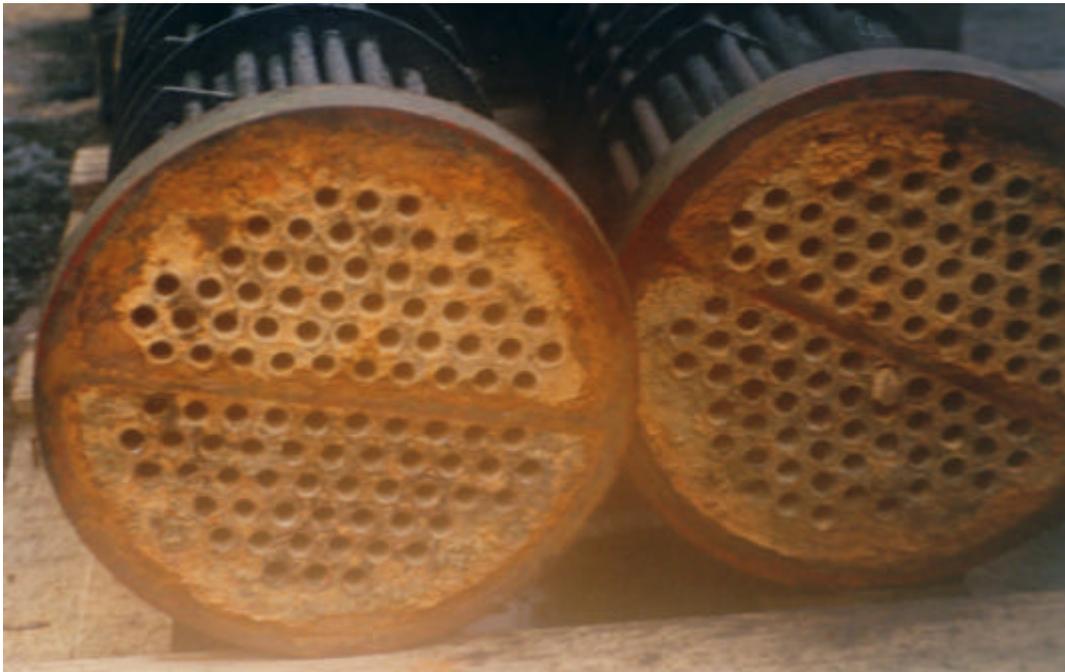
Figure 17. Tube sheets of the oil coolers equipped with copper tubes

Figures 17 and 18 present the respectively the galvanic corrosion encountered in a copper tubes oil cooler from a refinery, and a SS tubes oil cooler from a fertilizer plant.

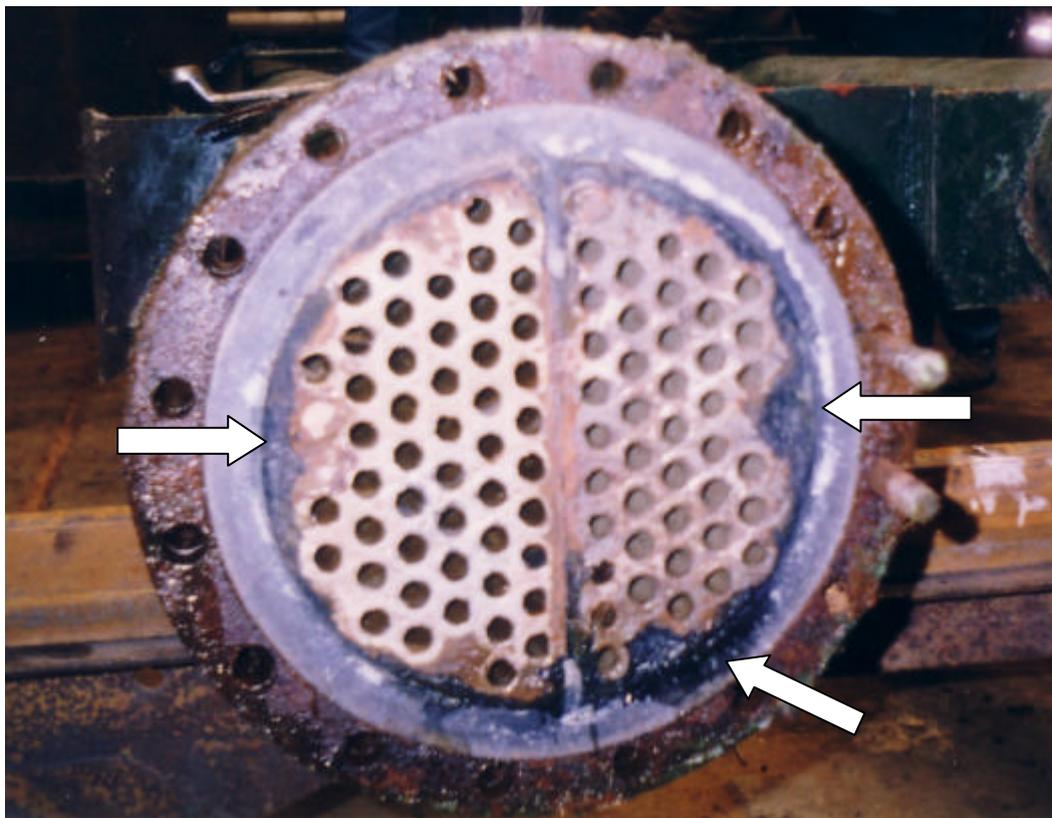
Figure 18. Tube sheets of an oil cooler equipped with stainless steel tubes

In the oil cooler presented in Fig. 18, several leaking tubes were plugged with SS plugs. The corrosion is more accentuated in that areas, the depth of the attack being of 3 - 4 mm, instead of 1 - 2 mm in the rest of the tube sheet. This may be explained by the increase of cathodic area, thus the anode/cathode area ratio being modified disadvantaging the mild steel tube sheet.

In order to avoid in the future the encountered problems, the tube sheets were sand blasted and filled by welding with stainless steel filler. This will eliminate the galvanic corrosion of the tube sheet, but the attack on the separating wall from the water box will persist, unless it won't be properly insulated (e.g. rubber gasket between tube sheet and wall).

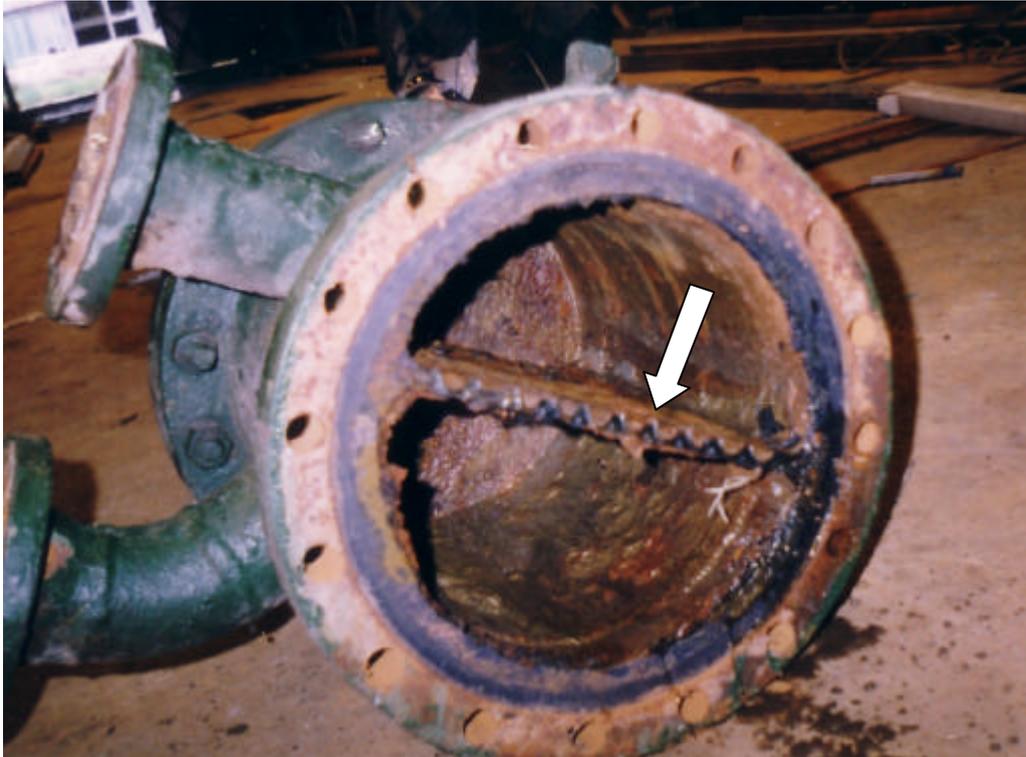
Figure 19. Water box of the oil cooler equipped with stainless steel tubes

Fig. 19 presents the inlet/outlet water box of the same heat exchanger. An interesting corrosion pattern may be observed at the edge of the separating wall of the water passes. At a previous dismantling, the water box has been wrong positioned (rotated with 180°). Due to the imperfect symmetry of the tube sheet, the separating wall was in contact not with the mild steel tube sheet but with the ends of a SS tubes row, thus generating a very active galvanic cell.
