## **RISK MANAGEMENT IN INDUSTRIAL COMPANIES, CASE STUDY: COLLECTIVE WORK ACCIDENT AT A BREWERY**

## CASE STUDY: COLLECTIVE WORK ACCIDENT IN A BEER FACTORY

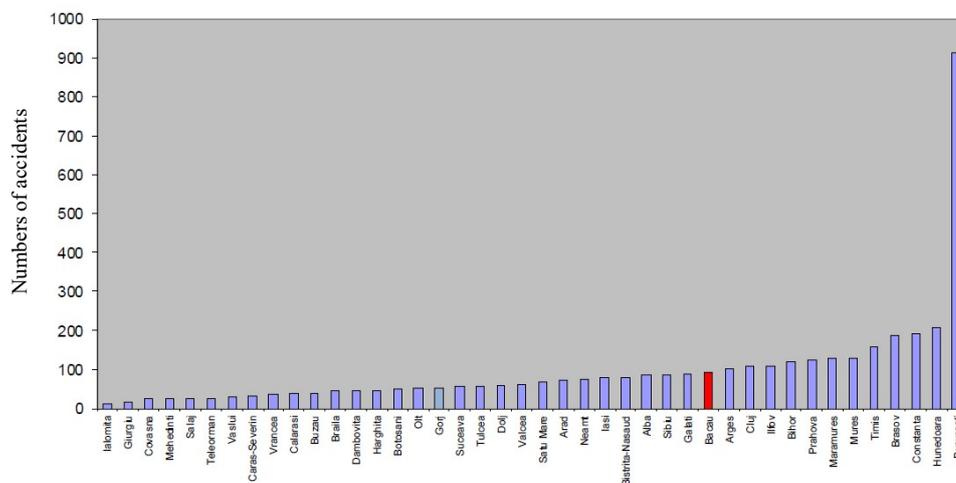
**Figure 1.** Distribution of the number of accidented persons during 2017, by counties

Figure 1 presents that, Bacau County, is on 30<sup>th</sup> place at the national level, and the last place in the North-East Development Region in 2017.

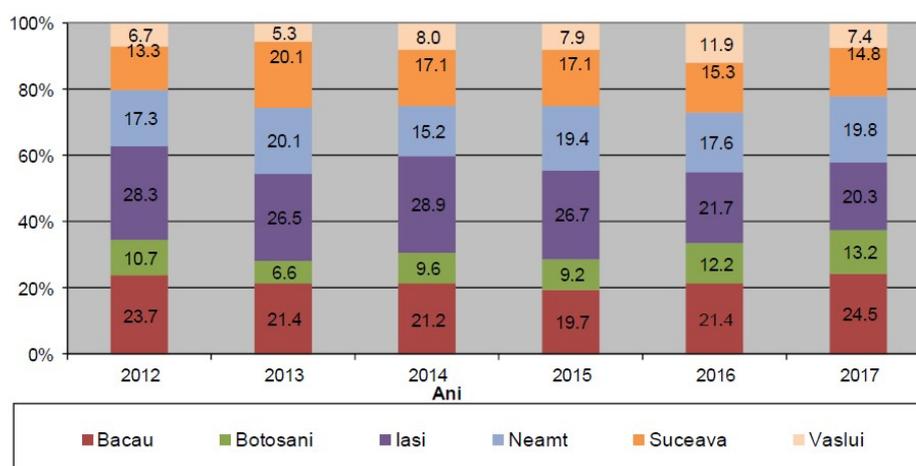
**Figure 2.** Evolution of the structure of the number of work accidents, by counties of the North-East Development Region (%)

As can be seen from Figure 2, with this number of work accidents, Bacau County is positioned on the last places, during the analyzed period, within the North-East Region (ranking in the ascending order of this indicator), the lowest weight being in the year 2017 (19.7 %).

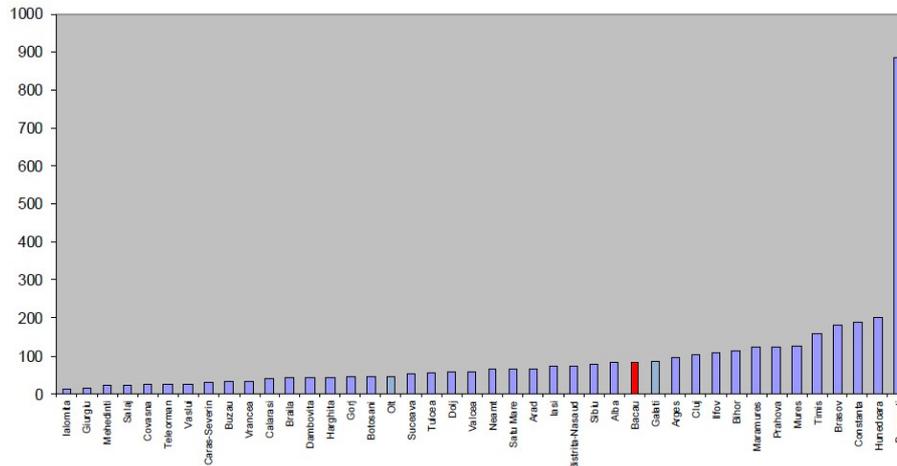
**Figure 3.** Distribution accidented persons number, with temporary incapacity for work, during 2017, by counties

As can be seen from the Figure 3, according to the distribution by counties, the municipality of Bacau is positioned on the last place, from point of view of this indicator.

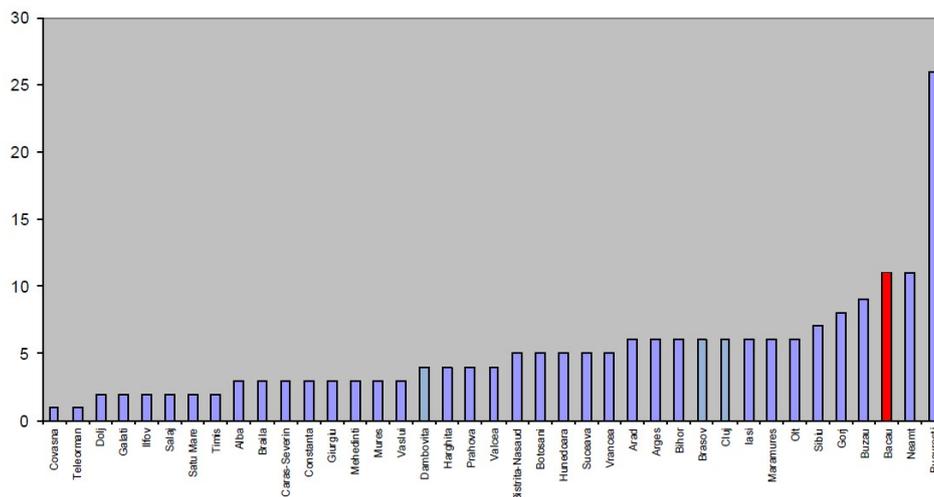
**Figure 4.** Distribution of fatal accidents persons number, during 2017, by counties

With this effect, Bacau county is ranked on 37th at national level, unfortunately, disputing penultimate place in the country, with Neamț county, as can be seen in the Figure 4.

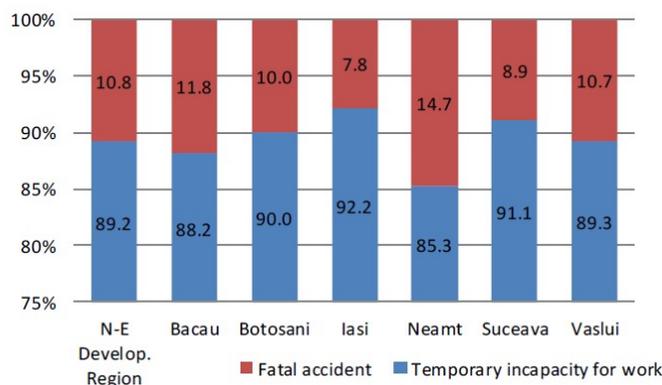
**Figure 5.** Structure of the number of work accidents, by accident categories and by counties, of North-East Development Region, during 2017 (%)

From Figure 5, it can be seen that the lowest share of deadly accidents persons in 2017, within the North-East Region, is registered in Bacau County (88.2 %).

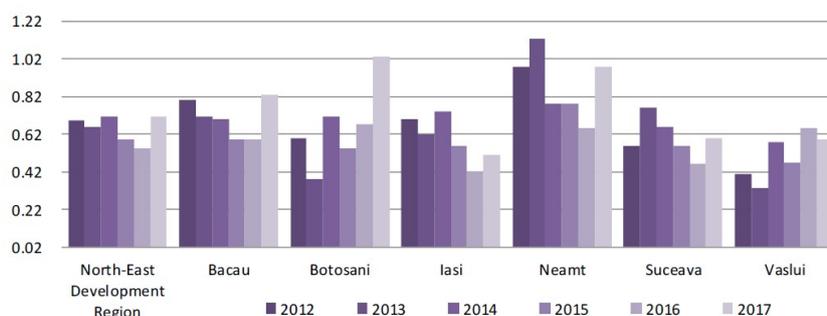
**Figure 6.** Rate of work accidents, from the North-East Development Region, by counties

Figure 6 is suggestive to best represent the fact that the values recorded in Neamt County on this indicator are significantly higher than the rates recorded in the other counties.

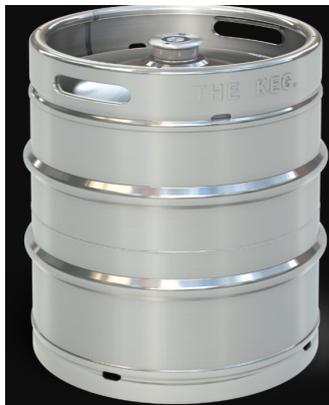
*Figure 7. Cylindrical barrels keg [33]*

Lately, the use of cylindrical barrels, made of stainless-steel sheet, called KEG, has spread. They can be 30 L and 50 L, the wall thickness being  $1 \div 2$  mm (Figure 7) [33].

This type of barrel is equipped with a complex system called Sankey, permanently installed, which allows filling, emptying, cleaning and sterilization. The advantages of using these barrels are [33]:

The Sankey type system is a component of the barrel, and is fixed by screwing, and during transport it is protected by a plastic cover.

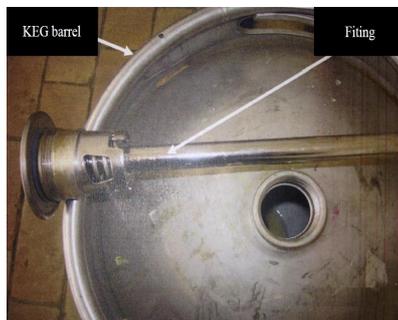
Figure 10. Photo from research file (KEG barrel, fitting) [34]

The KEG barrel fitting is made of stainless steel, and consists of a rod, fitted with a metal head, with a sealing gasket and a valve for supply-emptying [34].

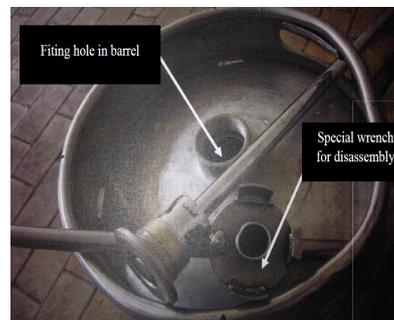
Figure 11. Photo from research file (fitting hole in barrel and special wrench for disassembly) [34]

For opening of KEG barrels in order to check them, a special key is used, depressurizing the barrel and unscrewing the fitting:

- KEG barrel is depressurized, in protected space specially arranged for this type of operation;
- ripping the fittings.

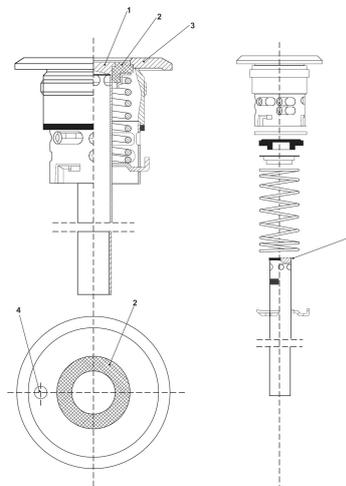
Figure 11. Photo from research file (technical sketch) [34]

KEG barrels, having the following dimensions: height 600 mm, outer diameter 400 mm, mass 12 Kg, provided with safety yielding at a pressure of 0.35 (+/- 0.05) MPa, are made of stainless steel. They have a capacity of 50 liters, the maximum admitted pressure 0.35 MPa, being loaded with beer under the air "pillow", at a pressure of 0.22 / 0.25 MPa (Figures 9 - 12) [34].

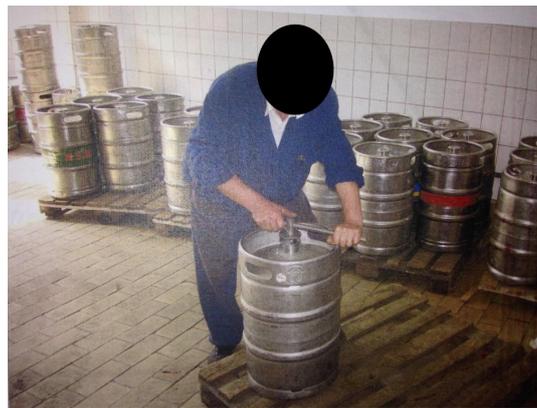
***Figure 12. Photo from the research file / event reconstruction [34]***

Worker L. I. started the unthreading of the fitting, a noise was heard as a result of the sudden release of the remaining pressure, and the fitting was threwn with power from the barrel, hitting him in the front area of the head [34].

- Failure to comply the instructions for safety at work when checking of the KEG barrels, by the worker L.I. He performed the unthreading of fitting, without having previously performed the pressure removal operation in a bent position above the fitting, in open space and not in the protected space intended for this type of operation. Thus, he exposed to the danger of accident, both his own person and the others involved in the technological process of bottling beer in KEG barrels (Figure 12).
