## SOME FAILURE MODES OF POLYLITE 440-M888 POLYESTER RESIN REINFORCED WITH RT300 ROVING FABRIC SUBJECTED TO TENSILE LOADINGS

**Abstract:** The paper presents some failure modes occurred in tensile tests of Polylite 440-M888 polyester resin specimens reinforced with RT300 roving fabric, specimens that have been cut in warp direction of the reinforcement. Tensile tests results are also presented. The first failures of the specimens took place in the form of inter-fibers brake at a strain of about 0,03.

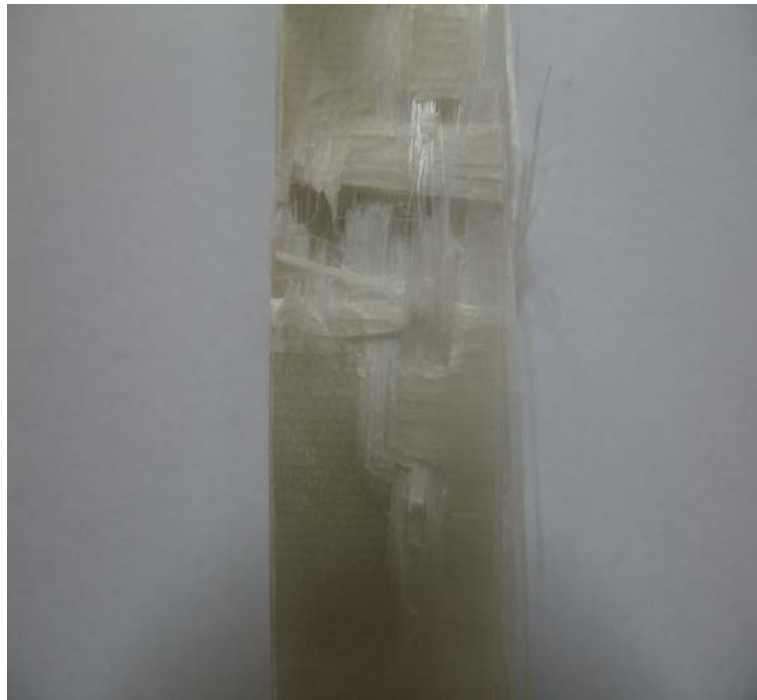
Fig. 2. Front view 1 of the failure mode

The first specimens failures have occurred at a strain of about 0,03 and took place in the form of inter-fibers brake. The effect of inter-fibers brake is not so spectacular as in the case of specimens based on PolyLite 440-M888 polyester resin reinforced with chopped strand mat CSM600. The crack that primes the inter-fibers break take place on a smaller length than in the case of specimens reinforced with CSM600. Some failure modes of specimens based on PolyLite 440-M888 polyester resin reinforced with 12 layers of RT300 roving fabric, specimens cut in warp direction of the reinforcement are presented in fig. 3 – 7.

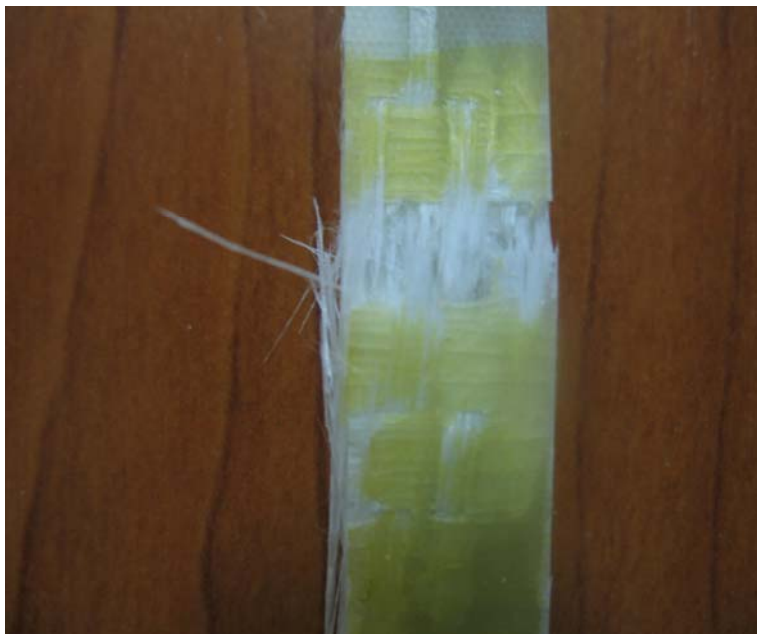
Fig. 3. Front view 2 of the failure mode

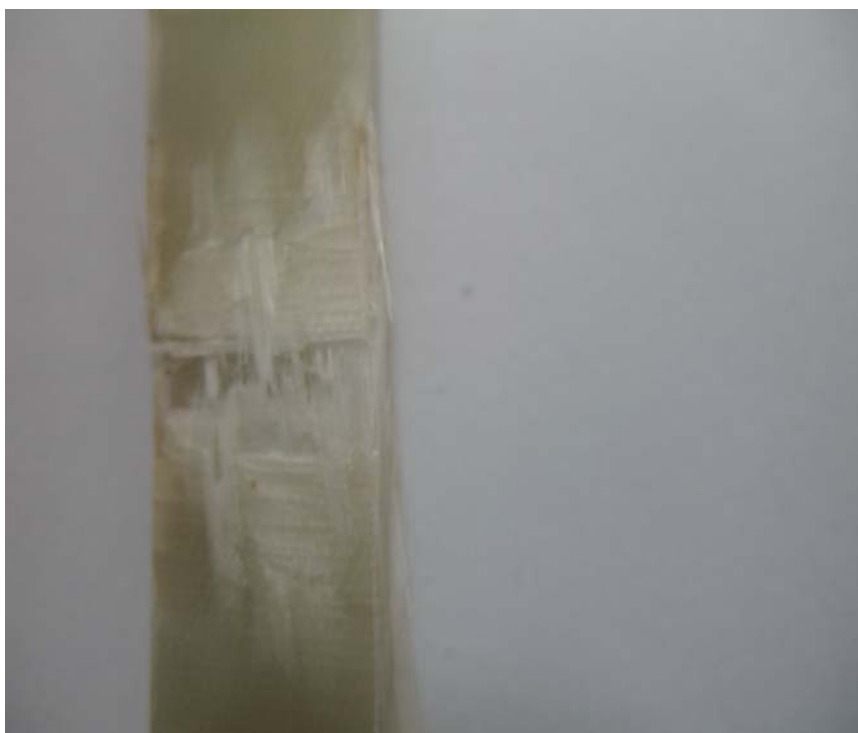
Fig. 4. Front view 3 of the failure mode

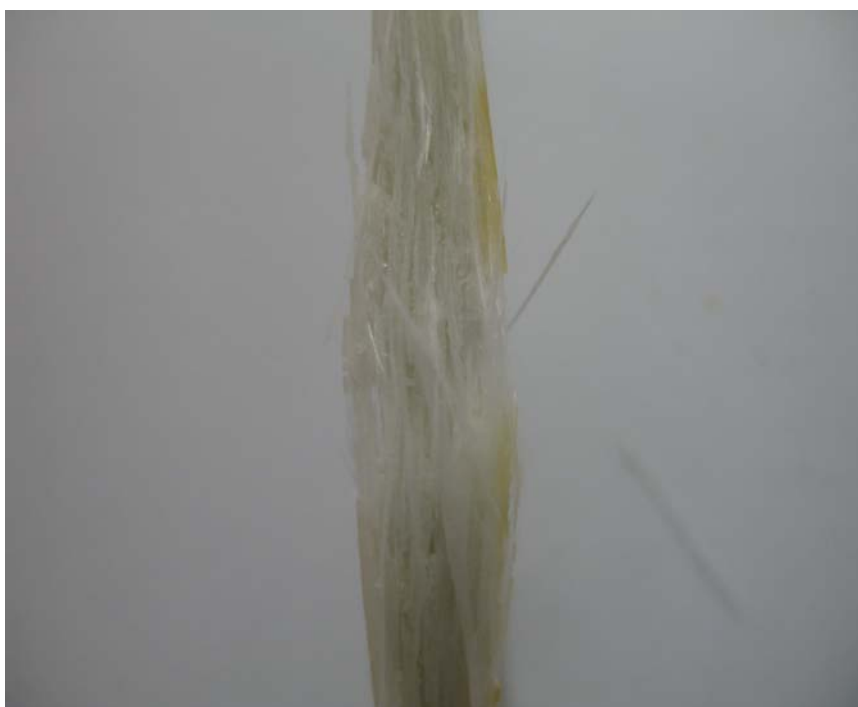
Fig. 5. Lateral view of the failure mode
