## FAILURE OF SHELL AND TUBE HEAT EXCHANGERS FROM INDUSTRIAL COOLING WATER SYSTEMS

**Abstract:** The paper presents the most frequent failures encountered in shell and tube heat exchangers used as cooling equipment in different technological processes, due to poor design, manufacturing faults, improper operating, maintenance and repairing. The conclusions of the paper are based on the monitoring of several cooling systems from chemical and petrochemical plants, power plants and oil refining facilities, during almost a decade of service.

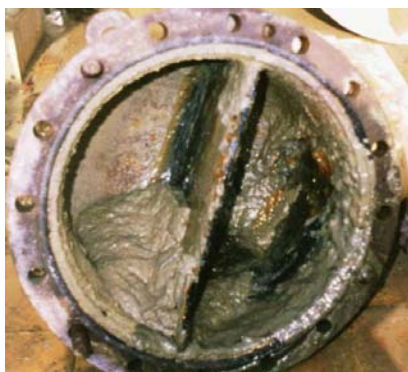
The minimization of heat transfer capacity is evidenced, in most of cases, after days or weeks from starting up the plant. It is the effect of **fouling** and **scaling** that can be produced by suspended solids, precipitated dissolved solids, corrosion products or microbiological slime from cooling water. Fouling and scaling of STHE tubes is a problem of design and/or operation. To avoid sedimentation of suspended solids, water velocity in tubes has to be 1 – 2 m/s. At lower water velocities (0.9 – 1.1 m/s) large sediments can accumulate in water boxes (Fig. 2) or on baffles, if cooling water flows on the shell side (Fig. 3). Even a good design cannot avoid fouling if cooling water is not properly treated and conditioned [8] or if water flow through the exchanger is reduced [9].

Fig. 2. Sediments accumulation in water boxes

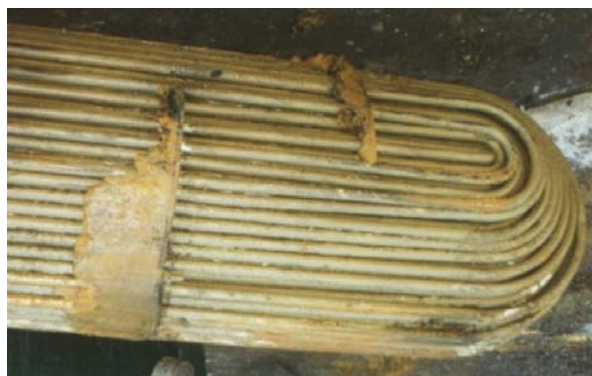
Fig. 3. Sediments accumulation at baffles

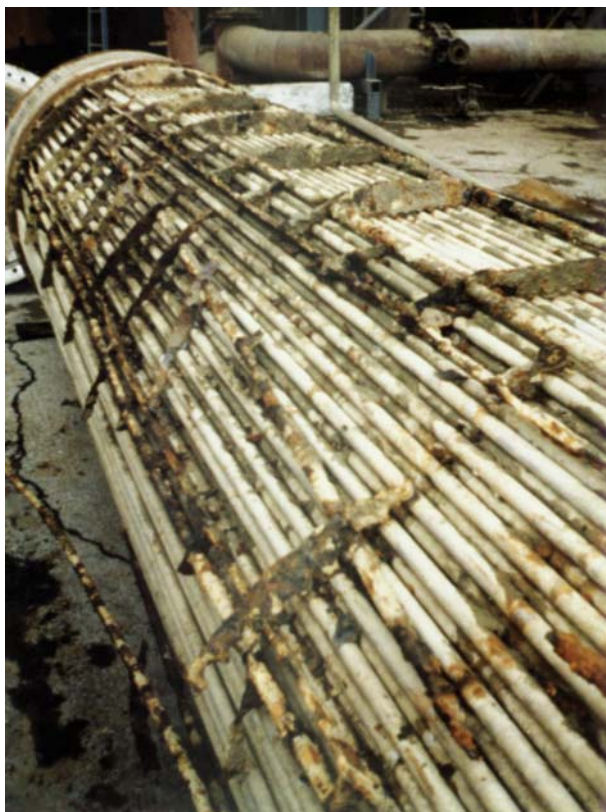
3. **Do not** replace mild steel bundle with nobler stainless steel bundle, if rods and baffles are made in carbon steel. In several months they will “disappear” due to galvanic corrosion (Fig. 7) [12, 13].

Fig. 7. Mild steel baffles and rods severely corroded in chemically treated water due to the contact with stainless steel tubes bundle

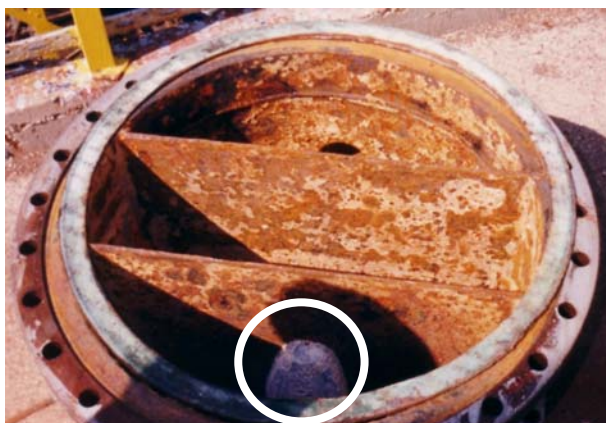
Fig. 8. Water box of a heat exchanger protected with zinc sacrificial anode

4. **Do not** use mild steel water boxes in contact with stainless steel tube sheets unless this situation can not be avoided. In that case use some protection: rubber gaskets to insulate stainless from mild steel, sacrificial anodes (made in zinc or magnesium – Fig. 8) placed on the mild steel walls, epoxy coatings.
