## ECOLOGICAL ANALYSIS OF THE TROTUS BASIN (CASE STUDY BACAU COUNTY)

**Abstract** The authors analyze the causes which generated the disastrous events in the summer of year 2005 in the hydrographic basin of the Trotus River, stressing those generated by ecological dysfunctions, due to the brutal intervention of people through extensive deforestation of the slopes of the Trotus River's tributaries and of the mountainous area the river flows through in Bacau County.

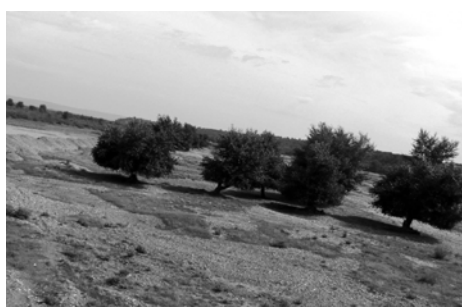
Fig. 2  
Ecologically devastated area near Urechesti. Of a large meadow forest but a small group of more resistant trees are still in place.

a) Until the disaster there were 15,000 ha meadow forests along the Trotus flood plain with species dominated by poplar trees, alder trees, willows and numerous annual and perennial herbs. At least 120,000 tons/year of biomass were lost this way, the energy equivalent of 70,000 tons of petrol, i.e. 350,000 kW/h of electricity. Biodiversity, genotypes and the specific genetic fund of the meadow was lost (fig.2).

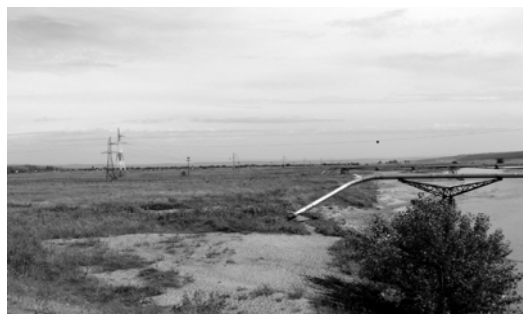
Fig. 3  
Eroded soil lost for the productive circuit with poor economically useless vegetation (Slobozia – Urechesti area)

b) By the enlargement of the riverbed an additional 4,500 ha of fertile meadow land was lost (fig.3 and fig.4).

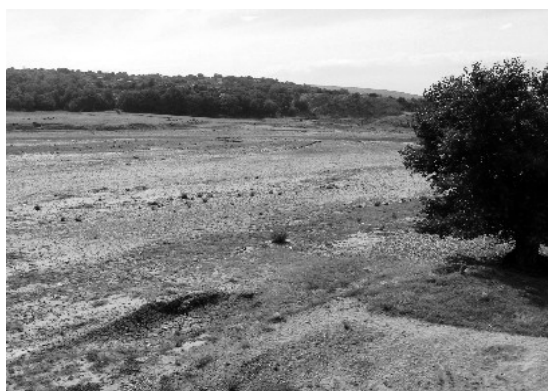
Fig. 4  
A year after the floods, an area wholly compromised ecologically, needing over 10,000 Euros in investments for reconstruction

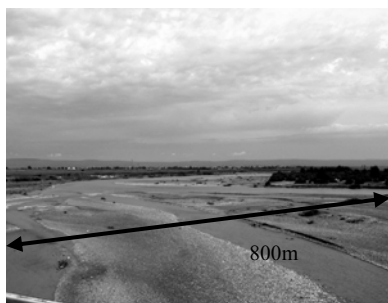
Fig. 5

The water bed of Trotus at the Bacau County's border with Vrancea County. The riverbed is 800 m wide and the river flows through three courses.

Fig.5 features the riverbed of Trotus at the border with Vrancea County. The riverbed has a width of over 800 m and the river flows along no less than three courses: to the North of Comanesti several flows can be noticed in the new riverbed of the river (fig.6). Though embedded in rock, the river managed to create two flows and between those there are huge deposits of rock transported by brooks from the high mountains.

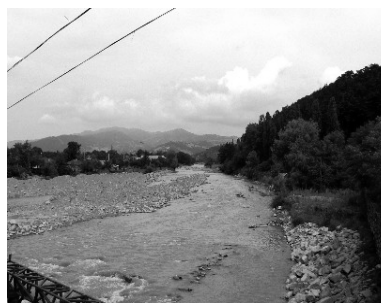
Fig. 6

Two of the courses of Trotus River and large quantities of rocks transported by rivers and brooks from the high mountains.

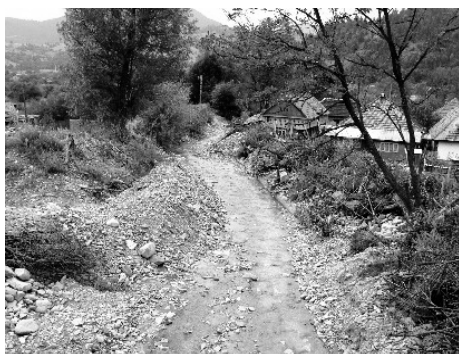
Fig. 12

Tens of thousands of tons of materials dislocated from the mountains were carried by 20 brooks towards the

The large quantities of rocks and deposits are estimated, for year 2005 only, at over 150 million tons. They blocked the riverbed, modified its course, affected localities, crops and infrastructure (fig. 12). It is to be noticed that due to infiltrations even the slopes covered with perennial and annual plants started showing some forms of landslides, in areas that were formerly stable (fig. 13).

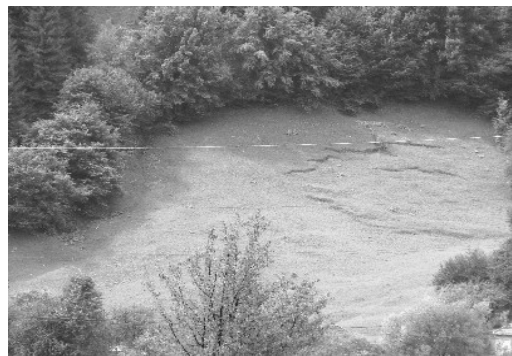
Fig. 13

Landslides appear on well kept surfaces too if the surrounding areas became unstable
